Manhole Inspection Summary

Manhole # S29YY_011MH

Location Address: **3236 KESWICK RD**

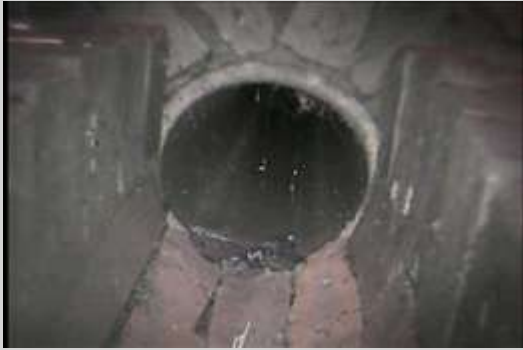
8 in. Circular Gravity Sewer

Rod and Bar (Angled)

Pipe Material: **Clay** ☐ Pipe Lined

Infiltration: **None** Pipe Seal Cond: **Unknown**
